Failure Analysis of Three Si_3N_4 Balls Used in Hybrid Bearings

15 February 2003

| 7. PERFORMING ORGANIZATION NAME(S) AND ADDRESS(ES) The Aerospace Corporation Laboratory Operations El Segundo, CA 90245-4691 | | | | 8. PERFORMING ORGANIZATION REPORT NUMBER TR-2003(8565)-1 | |

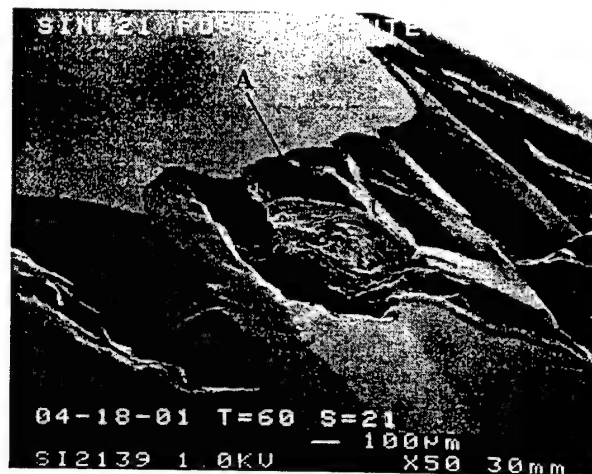
Figure 3 is a low-magnification view of the entire spall from a perspective perpendicular to the surface. The Wallner lines radiate on the left and right from an initiation site labeled "A," with the concave sides of the Wallner lines pointing back towards this initiation site, which is a broad, flat "plateau." Figure 4 is a more highly magnified view centered to the left-hand side of the initiation site "A," and Figure 5 is a companion view centered to the right-hand side. Figures 4 and 5 are taken at oblique angles to highlight the concave Wallner lines, which again are seen to point back towards the site "A," which is, therefore, identified as the initiation site.

Figure 4. View centered to the left-hand side of the initiation site "A."

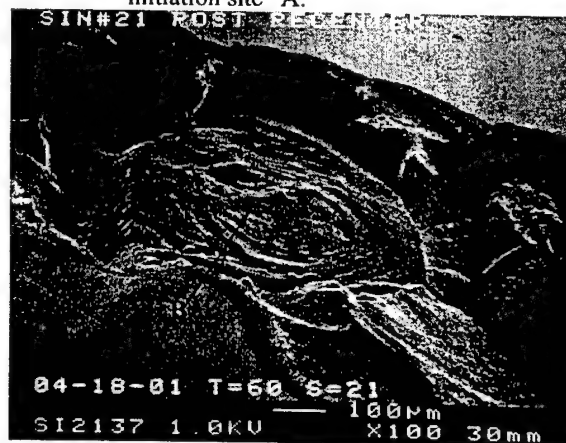
Figure 6 is a more highly magnified view (at 100x) centered on the site "A" from an oblique perspective. The circular Wallner lines seen in site "A" form a "bull's eye" pattern around a central point, labeled "B." The pattern of Wallner lines implies that the site "B" is the upstream location where failure initiated. Detailed inspection of site "B" at still higher magnifications did not seem to reveal a clear cause for the initiation of the fracture.

Figure 6. View centered on the initiation site "A" showing a central "bull's eye" pattern of Wallner lines.

The fractographic analysis of the first Si_3N_4 ball in Subsection 3.3.1 identified the initiation site for the failure, but did not identify the microstructural feature responsible for the initiation. It is possible that the microstructural feature did not survive the failure.

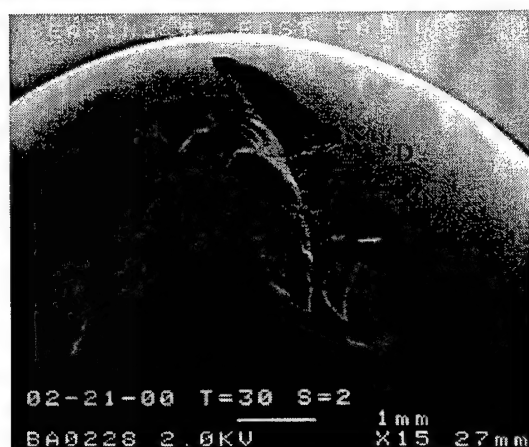
Figure 7 is a low-magnification view of the entire spall. To orient the discussion of subsequent fractographs that show finer detail, five features are labeled in Figure 7. In this view, the circular Wallner lines are evident in the upper and left-hand parts of the spall. In particular, feature "A" is a region of Wallner lines in the middle of the spall. Feature "B" is a region of Wallner lines upstream from feature "A." The concave lines radiate back to a point labeled "C," which is a void in a triangular pocket defined by the intersection of three cracks. (In the following more highly magnified fractographs, feature "C" is shown to be a void). The long feature labeled "D" is a deep "trench-like" fracture. An interesting feature, labeled "E," is a patch of virgin surface that did not spall away.

Figure 7. View of the entire spall.

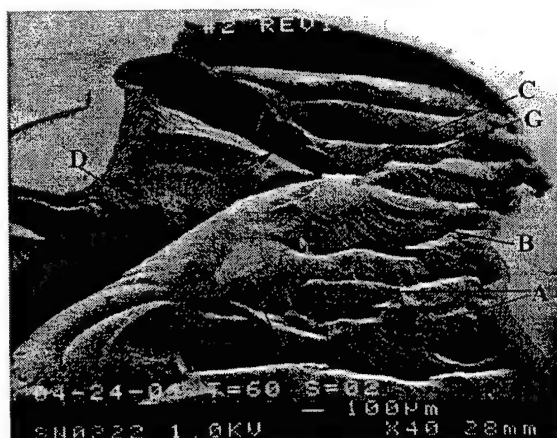
Figures 8 and 9 are low-magnification views taken by successively rotating the line of sight. The concavity of the Wallner lines, labeled "A" and "B," again reinforces that fracture initiated in an upstream location in the neighborhood of the feature "C," from which radiates the deep fracture "D." Two other cracks, labeled "F" and "G," also radiate from the feature "C." To provide a landmark, the location of the unspalled virgin surface is labeled "E."

Figure 8. View from an oblique perspective of Wallner lines downstream from the initiation site, "C."

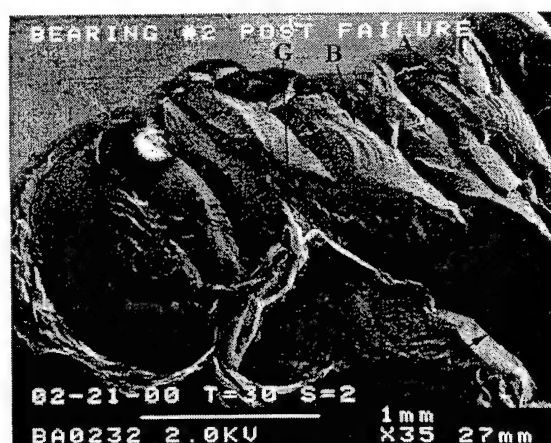
Figure 9. View of from an orthogonal perspective Wallner lines downstream from the initiation site, "C."

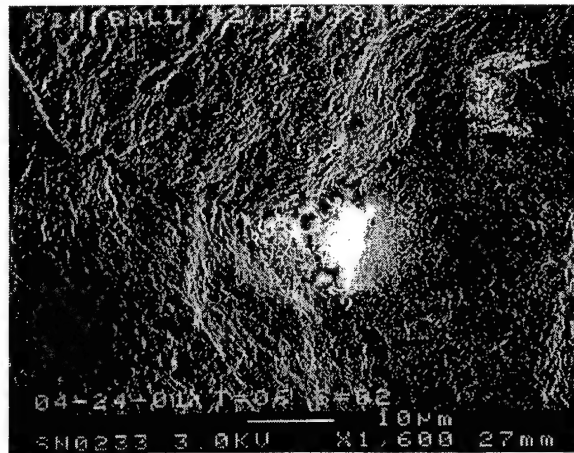
Figure 14. The void and its vicinity display charging at a slightly elevated accelerating voltage of 3 kV.

The fractographic analysis of the second Si_3N_4 ball in Subsection 3.3.2 showed a small void that sits in a triangular region whose appearance differs from the fracture surface around it, which is seen most clearly in Figures 12. This change in appearance may imply that the triangular region is not the same chemistry as the material around it. For example, the region may be a pocket of segregated glassy material at the triple junction between adjacent grains of crystalline Si_3N_4 . The observation that the triangular region charges implies that the region has a higher electrical resistivity than the material around it. A higher electrical resistivity might be consistent with a pocket of glassy material rich in the sintering aids used in this Si_3N_4 . The glassy sintering aids might be expected to be more insulative than the bulk Si_3N_4 ceramic.

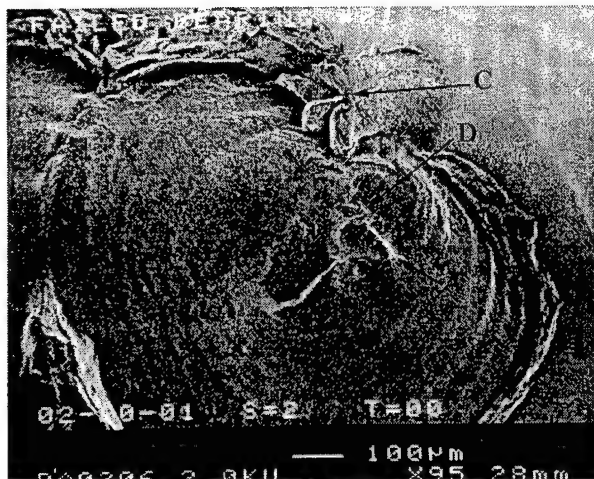
Figures 18 through 21 are progressively more highly magnified views (at 95x, 300x, 3500x, and 15,000x, respectively) of a separate crack-like feature, labeled "E," from an orthogonal perspective. Feature "E" is at the base of feature "A" near feature "D." Features "A," "B," and "D" are labeled in Figures 18 and 19 for orientation. The feature "E" is just inboard of the tightly spaced Wallner lines in the upper right-hand corner of Figure 19, which reinforces the notion that feature "E" is in the right location to be the site for fracture initiation. Figures 20 and 21 show an interesting structure in the crack-like feature "E." In the structure, ligaments span the crack-like feature. The discussion section expands upon the possible significance of the ligaments.

Figure 18. First in a series of four views centered on the initiation site.
